OHIO HISTORIC INVENTORY

1. No. LOR-1652-21		2. County Lorain		4. Present Name(s)		1. No. LOR-1652-21
3. Location of Negatives O.H.I.O. Resource Cen		5. Historic or Other Name(s) Morrison-Martin House				
Roll No. 12		Picture No.(s) 06,09		16. Thematic Associations: College, AGRICULTURE, Music		2. County Lorain

6. Specific Address or Location 75 Elmwood Place		17. Date(s) or Period c. 1910-1916		17b. Alteration Date(s)		
6a. Lot, Section or VMD Number 0900-085-108-036		18. Style or Design Craftsman/Arts and Crafts,		High Style Elements Yes		4. Present or Historic Name(s)

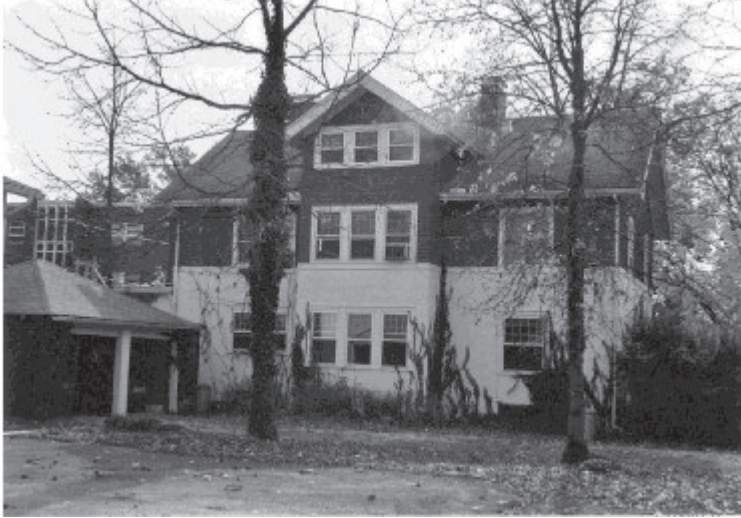
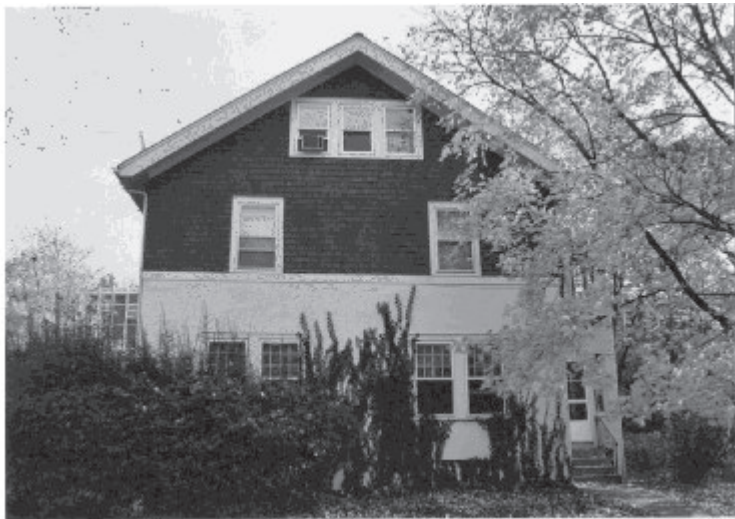
1. No. LOR-1652-21	2. County Lorain	4. Present Name(s)	1. No. LOR-1652-21
3. Location of Negatives	O.H.I.O. Resource Cen		
Roll No. 12	Picture No.(s) 06,09	5. Historic or Other Name(s) Morrison-Martin House

42. Further Description of Important Interior and Exterior Features (Continued on Reverse if Necessary)						75 Elmwood Place
<p>This home displays elements of the Craftsman/Arts and Crafts style in the use of its stucco exterior, and south facade porches. The south facade would probably be considered the "front" of the house. This elevation contains an enclosed porch at both stories, with ribbons of four-over-one windows. Double doors for the porch face the west elevation, and cement steps with an iron rail lead up to the doors. Fifteen-over-one windows are located left continued...</p>

of the porch at each story, and the first story also contains a fixed twelve-panel window. The west elevation contains pairs of twelve-over-one windows at the left and right sides of the first story. A single twelve-over-one window is located at the second story. Three twelve-over-one windows are located in the attic. At this elevation, the stucco exterior of the first story is seen below the wood shingled second story. The gable roof contains a plain, wide wood cornice. At the north elevation, the center section projects and contains a cross gable. The first and second stories, as well as the attic, contain pairs of twelve-over-one windows. The attic windows are not as tall as those in the first and second story. A door is situated at the left corner of the elevation. At the far left of the elevation, wood stairs lead up to the flat roof of a first story wing.
