# OHIO HISTORIC INVENTORY

1. No. LOR-1771-21		2. County Lorain		4. Present Name(s)		1. No. LOR-1771-21
3. Location of Negatives O.H.I.O. Resource Cen						
Roll No. 7		Picture No.(s) 16, 17		5. Historic or Other Name(s) Bowie House		2. County Lorain

6. Specific Address or Location 192 North Prospect Street		16. Thematic Associations: African American, Health Care, College		28. No. of Stories One story		
6a. Lot, Section or VMD Number 0900-074-104-013		17. Date(s) or Period c. 1962		17b. Alteration Date(s)		4. Present or Historic Name(s)

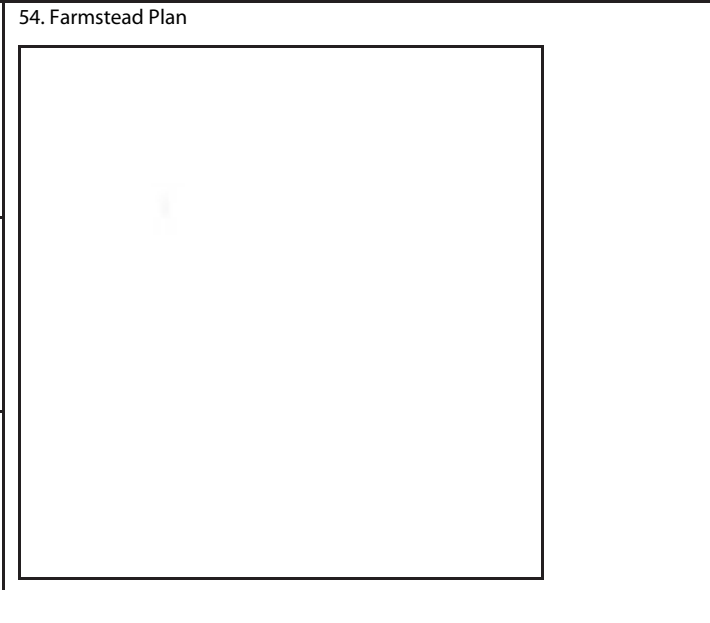
42. Further Description of Important Interior and Exterior Features (Continued on Reverse if Necessary)						6. Specific Address or Location 192 North Prospect Street
<p>This Wrightian house has a flat roof, with one level sticking up at the center of the main roof. The tall portion of the roof has ribbons of windows at each elevation. The front elevation has an attached one-car garage, with a door to its left, at the far right of the elevation. The area containing the garage is set far back from the front facade, parallel to the street. The portion near the street contains four tall windows at the far left, and continued...</p>

a door near the center. A rectangular window is located to the right of the door with three casement windows to the far right. The north elevation has a door on the left, flanked by rectangular windows. A second door is located left of center with two sets of casement windows to the right. The south elevation has four large windows at the right and three smaller, casement windows at the left side. The chimney is visible at this elevation; it is wide and is comprised of squared and coursed rubble.

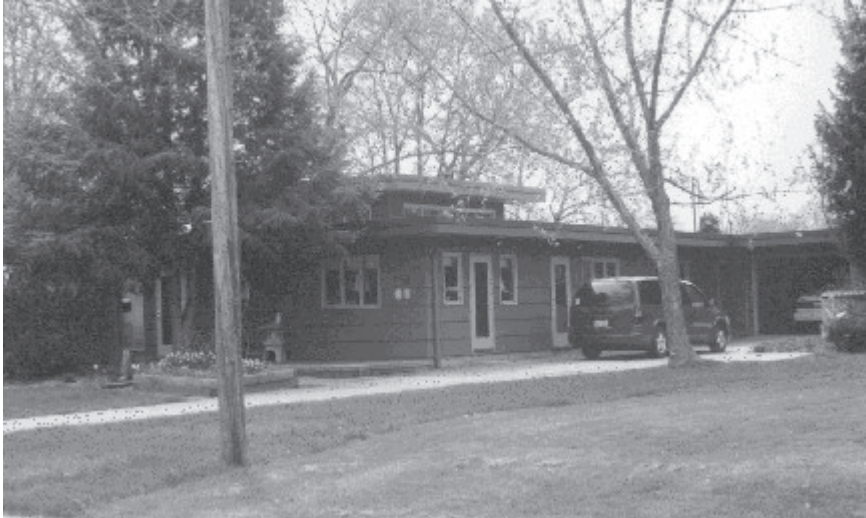
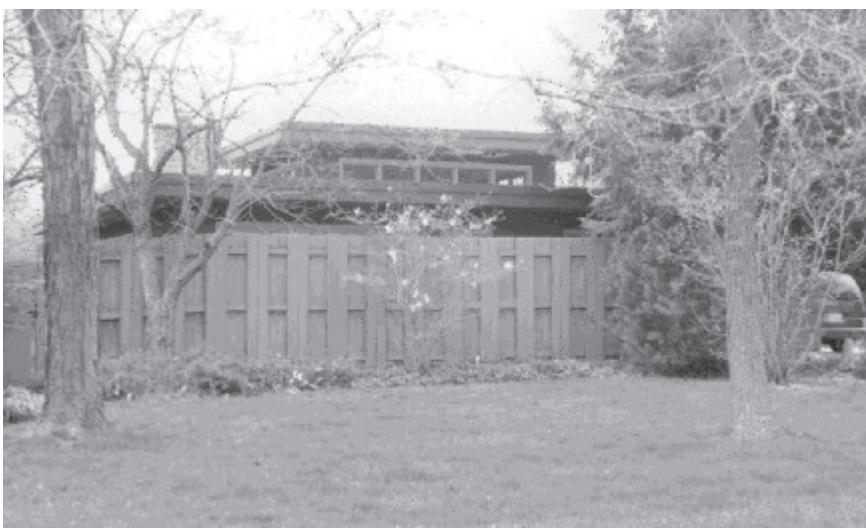
1. No. LOR-1771-21	2. County Lorain	4. Present Name(s)	1. No. LOR-1771-21
3. Location of Negatives	O.H.I.O. Resource Cen		
Roll No. 7	Picture No.(s) 16, 17	5. Historic or Other Name(s) Bowie House

44. Description of Environment and Outbuildings (See #52)						
<p>The home appears to be in very good condition and is located along a quiet residential street, primarily surrounded by homes built in the mid-twentieth century.</p>
