# OHIO HISTORIC INVENTORY

1. No. <b>LOR-1920-21</b>		4. Present Name(s) <b>East Hall</b>		LOR-1920-21
2. County <b>Lorain</b>		5. Historic or Other Name(s) <b>East Hall</b>		
6. Specific Address or Location <b>176 North Professor</b>		19a. Design Sources		Lorain

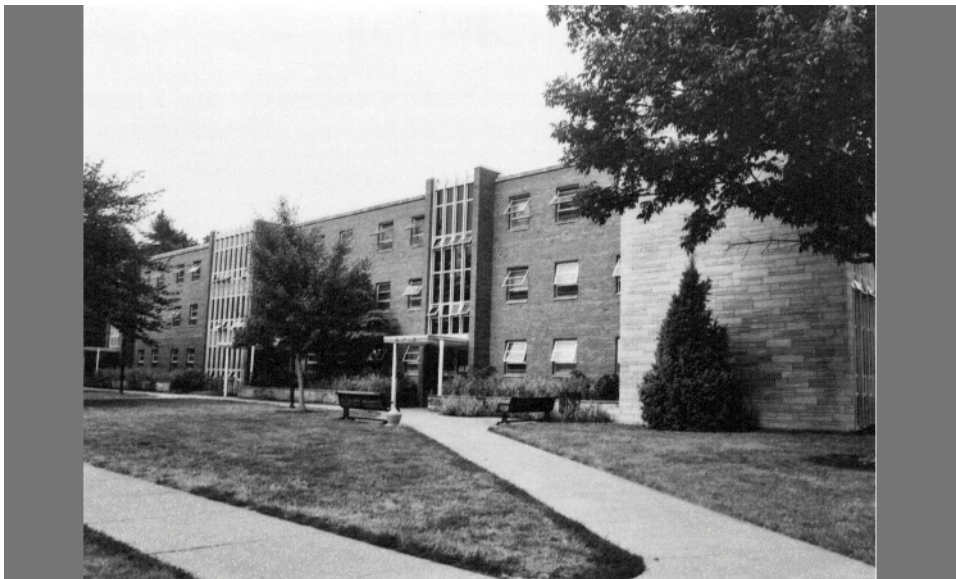
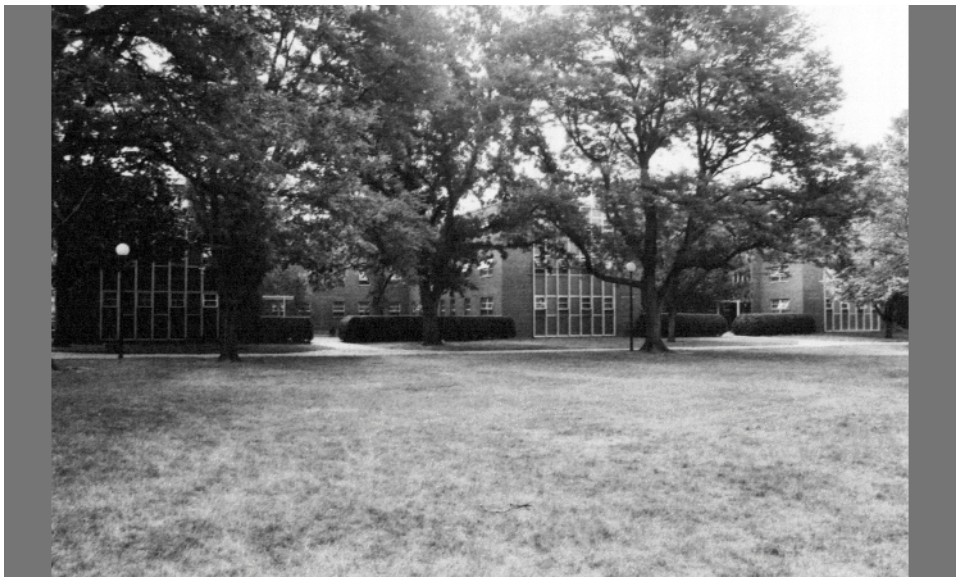
42. Further Description of Important Interior and Exterior Features (Continued on Reverse if Necessary) <b>This dormitory, which Virginia &amp; Lee McAlester would describe as 'Contemporary' style was designed in 1964 by architects Potter, Tyler, Martin &amp; Roth. Its 3 major wings are connected in the east to form an 'E' shape, with the 'spokes' at the west elevation. The 3-story building has mainly a brick exterior, but each end of the main (east-facing) facade is capped in the corners by a large 3-story bay of patterned ashlar which juts out a few feet from the main facade. Facing north &amp; south toward the center of the building, the two narrow strips created where these ashlar bays project out are covered with windows. The windows form a repeating pattern of filled panels, long, narrow rectangular windows, &amp; small square awning windows extend from the ground to the flat roof. These windows have prominent metal vertical mullions that extend beyond the roofline. Between the 2 projecting ashlar bays, the building's main facade includes 4 sections with 3 to 5 windows evenly-spaced in each story. These windows include an awning window atop a hopper window &amp; continue all around the building with slip sills. These 4 brick sections are separated by 3 projecting sections with continued...</b>

entrances in the 1st story & ribbons of windows extending to the roof. Brick pillars which extend, like the mullions, beyond the roofline flank the 3 projecting sections with entries and windows. Large, flat metal hoods supported by thin rectangular metal poles cover each of the three entrances, which contain doors of metal & glass flanked by large glass windows. Above the entrances on the left & right, ribbons of windows in an alternating rectangle-rectangle-small square awning pattern extend to the roofline, with the metal mullions continuing slightly beyond. The middle entrance differs slightly from those on the left & right; it is positioned not beneath but beside this projecting section with the ribbons of windows, so that in the center, the windows continue all the way to the ground. The central section of windows also includes filled panels in its pattern of rectangular & square awning windows, similar to the narrow strips on the side of the ashlar portions. This central entry, to the right of the windows, contains double doors and sidelights. A wide cement frieze runs all around the building. The ashlar portions continue around the corners from the main facade to the south & north elevations. Here 3-story plain ashlar columns flank ribbons of filled panels, square awnings, and rectangular windows similar to those on the main facade. Left of this section, the south elevation contains 8 windows in each story, with a pair right next to each other closest to the left corner. The north elevation largely mirrors the south, except the 1st story includes 2 double door side entrances above a cement stoop, as well as a few grates in place of windows. In the west elevation, the 'spokes' of the 'E' shape of the building create 2 inner courtyards which open to a campus quad on one side & are enclosed by the dormitory on the other 3. These courtyards are paved with cement on the outside & planted with vegetation on the inside. The right courtyard has 2 entrances, facing north & south. The left courtyard has 1 south-facing entrance. These are positioned toward the outside (west) of the courtyard, with 1 column of windows between them & the corners. These entrances echo those in the main facade, with glass & metal doors covered by a hood & ribbons of windows extending to the roofline with continuing mullions. The rest of the courtyard-facing elevations contain evenly-spaced awning/hopper windows with slip sills in each story & adjoining pairs to the outside of each entrance. Facing west, the 3 'spokes' contain 3 columns in the center, flanked by brick, which alternate filled panels with awning/hopper windows.
