## **OHIO HISTORIC INVENTORY**

1. No. <b>LOR-1929-21</b>	4. Present Name(	s)		] 2 5
2. County <b>Lorain</b>	5. Historic or Oth	Other Name(s) Sperry House		LOR-1929 2. County -21 Lorain

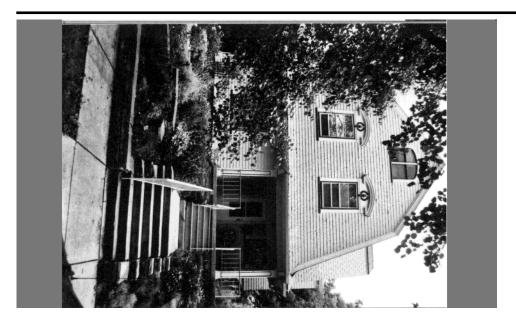
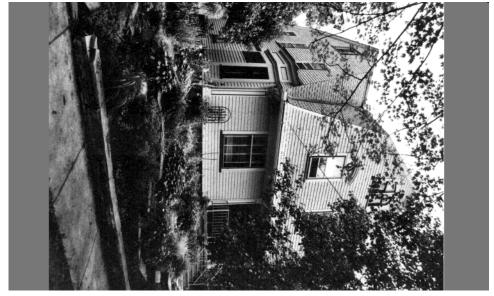
This Dutch Colonial Revival house features a recessed porch at the right corner of its main/south facade. Within the porch, the wood door has a large, oval window. A leaded & beveled glass window is right of the door. The porch has square pilasters & square columns supporting it. Left of the porch, a large 1/1 window has an upper sash that is smaller than the lower sash. Another square pilaster is located at the far left corner of the house. The second story features the gambrel gable indicative of Dutch Colonial Revival style. The gable extends to just above the 1st story & its wood shingles bow out at the 1st story. 2 1/1 double hung windows at the 2nd story have segmental arched pediments above the windows with a torch & laurel wreath design at the center of each arch. The arches have cornice returns. The attic has a pair of windows that form 1 arch with a wood 'keystone' at the top. The east elevation features a door at the center, below a projecting bay, which is supported by decorative brackets. A small window left of the door has muntins that form diamonds. The projecting bay has small, sawtooth shingles at the lowest row & features a pair of 1/1 double continued...

hung windows. The right side of the elevation has steps that lead to another door. Both doors have a window in the upper half & 3 filled wood panels below. A window is located between the doors. 1/1 double hung windows are located in the 2nd story to the left & right of the projecting bay. Another gambrel gable dominates this elevation & west elevation since the roof is a cross gable. The west elevation has a large 1/1 window with a small upper sash at the left side of the elevation. The right side has a bay window with a narrow 1/1 window that faces southwest (another likely faces northwest, but is not visible). The center window is leaded & has beveled glass. The bay has an entablature with dentil molding, frieze panels, & cornice. The 2nd story has 3 1/1 double hung windows. The attic has a pair of 6/1 double hung windows.
