# OHIO HISTORIC INVENTORY

| 1. No. <b>LOR-01933-21</b> | | 4. Present Name(s) <b>Jones Field House</b> | |
| 2. County <b>Lorain</b> | | 5. Historic or Other Name(s) <b>Jones Field House</b> | |

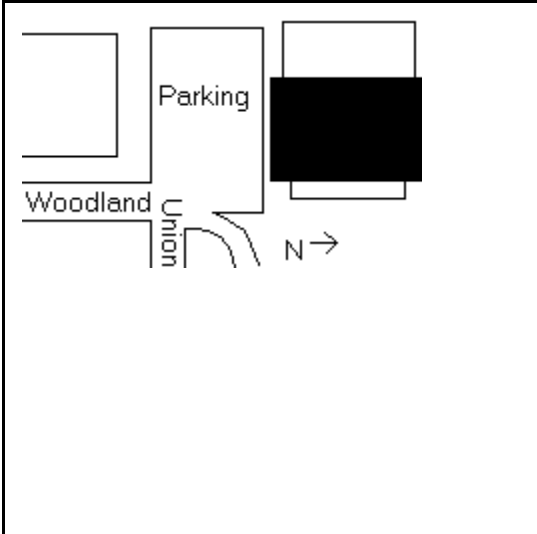
8. Site Plan with North Arrow

This complex of buildings is located at the north end of the Oberlin College campus. East of the grandstands of the stadium is the football field, which is circled by the asphalt track. A scoreboard is at the north end of the field. A soccer field is located to the west of the complex of buildings, with a scoreboard at the south side of the field. A large parking lot is located at the south side of this complex of buildings.

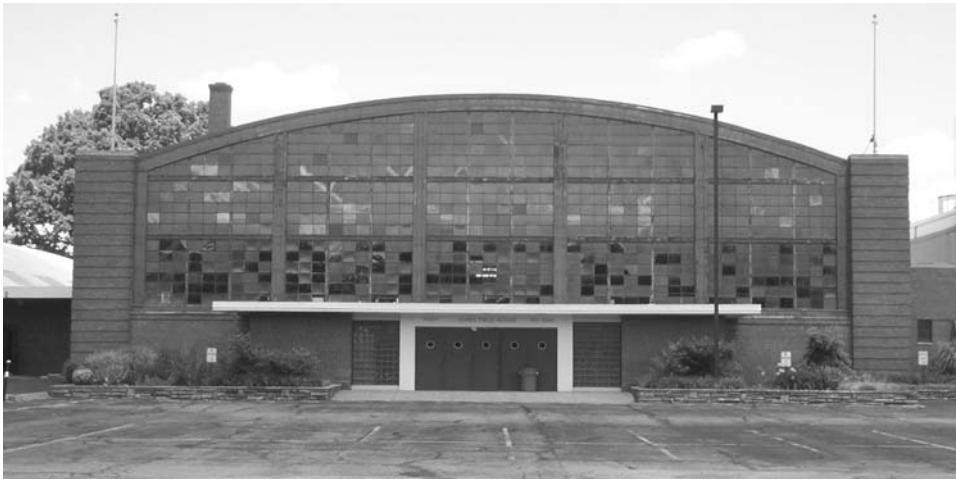
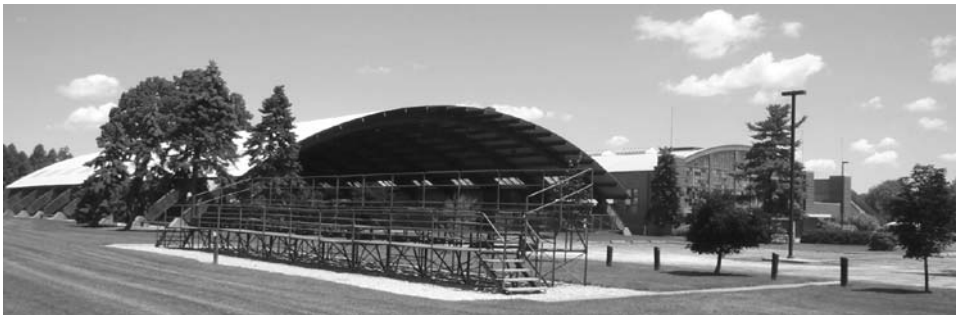
This collection of structures includes the Jones Field House at the center, a hangar style building, flanked by another hangar style building to the left (a former ice skating/hockey rink) and a grandstand/stadium to the right, which faces the football field and track. Flat-roofed wings connect the structures. At the front/south elevation, the field house features a flat-roofed portion that projects out from the building and contains the entry, which has wide, overhanging eaves. The entry has 5 doors, each with circular windows in the upper half. Above the doors, the words 'JONES FIELD HOUSE' are printed, with painted signs indicating 'TICKETS' and 'REST ROOMS' to the left and right, respectively. The doors are flanked by large glass block windows, while the remainder of the projecting bay is brick. The portion that does not project is brick at the lower third, with brick columns extending past the roofs at the far left and right. Every 6th row of bricks in the columns is recessed, to create horizontal rows. The segmental arch of the hangar roof dominates this facade. The face of the arch is covered with small, fixed windows that have steel muntins and mullions. continued...

The wing to the right that connects to the grandstand contains a variety of windows with steel muntins (both casement and awning windows) and cement sills. The second-from-left window has a screen that curves out to allow for the window to open out. The far right side of this elevation contains the grandstand. Another tall, brick column is situated behind the seating area of the stands. A steel casement window is just right of the column. A tunnel runs below the stands and has brick walls with cement piers. Within the tunnel, the walls facing west are brick; the walls within the tunnel on the east side have vertical and horizontal wood boards. The tunnel houses concession stands and locker rooms. The seating of the grandstand dominates the east elevation. Three portions of the stands are cut away to allow access to the tunnel. The bleachers are made of aluminum. A media box at the top of the stands has vertical wood siding and some original windows, which have simple square panes. Some windows have been replaced by 1/1 double hung windows. The media box has a flat roof with overhanging eaves. Three more wood boxes sit on top and have flat roofs, wood doors, and wood hinged window openings (no glass in these windows). The field-level bleachers are made of wood, rather than aluminum, which are fixed to the cement wall lining the bottom perimeter of the stands. A (possibly historic) tiny enamel/metal drinking fountain is mounted near the center of the cement wall. A metal fence surrounds the field. At the rear/north elevation, the wing connecting the stands to the field house has 2 6-light windows and a metal double door at the right, which has windows in its upper half. The field house has wood shingle siding at the east and west elevations. The rear of the field house has drop/novelty wood siding. The door at the center is wood and its upper half has been replaced with a modern sheet of plywood. A shed hood is above the door. The 2 windows at both the left and right of the door are large; they include 9 lights with heavy mullions. This elevation displays a high cement foundation. The wing connecting to the hockey rink is concrete block with a pair of wood doors at the center. The hockey rink itself is simple and it is an open-air structure. Its arched roof faces north and south, as in the roof of the field house. Steel and concrete arches are visible. The roof is covered in corrugated metal and plastic sheets; the sides do not have walls. The east elevation connects to a wing of the field house. This wall is mostly comprised of concrete block, but the south end is brick. In the wing, square windows have steel muntins and mullions. Windows wrap around the southwest corner of the brick portion. Directly to the left of the brick (at the portion with cement blocks), a door with windows is located to the left followed by another door to the left. Additional windows are located even farther to the left. The field house is currently classified as unsafe for use and is scheduled for demolition. The old ice rink will be renovated for a new field house. See also the entry for Dill Field, LOR-1883-21, also at 200 Woodland.
